**HALTEMPRICE PRIORY FARMHOUSE**  
**ABBAY LANE**  
**WILLERBY, HULL HU10 6ER**

**Grade II\* Listed building**  
**Scheduled Ancient Monument SM 32639**  
**Proposed re-instatement as a single domestic dwelling**

**PLANNING, HERITAGE,**  
**DESIGN AND ACCESS STATEMENT (PHDAS)**

**September 2011**

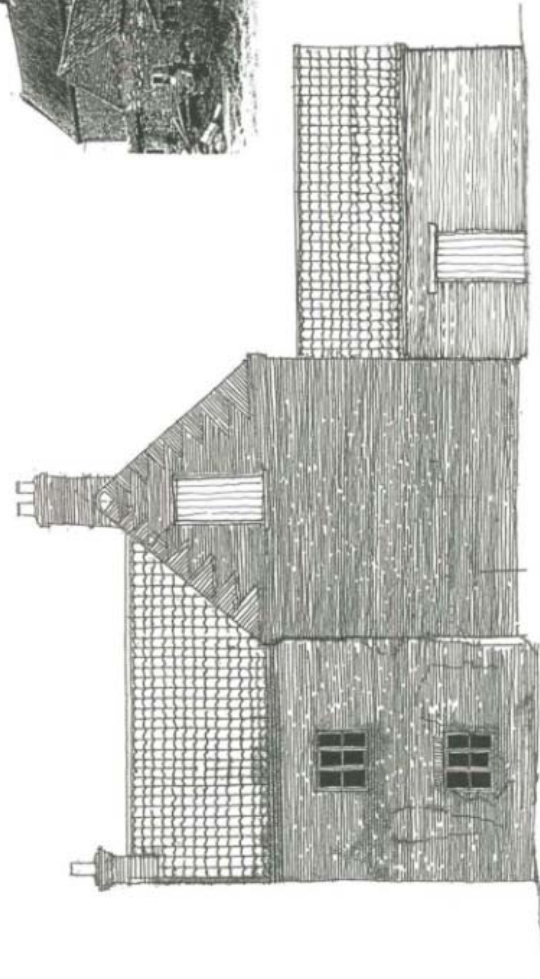
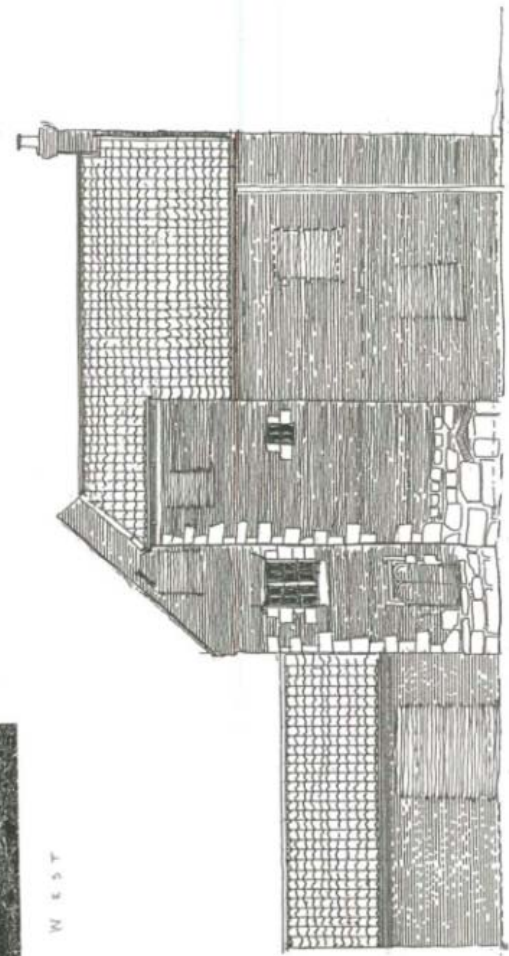
<p><b>HALTEMPRICE PRIORY FARMHOUSE</b> WILLERBY, HULL</p> <p>PETER GAZE PACE, A.A. DRG. P.L.A. FRIBA ARCHITECT THREEDRUMS, SPADWORTH ROAD, YORK, YO11 1ED Tel: 01753 811711 Email: peter@peterpace.co.uk</p> <p>Mr &amp; Mrs M. Blades</p> <p><b>ELEVATION'S</b> 1975</p> <p>JAN. 2010 DWG 7.</p>
---

EAST ELEVATION

WEST ELEVATION

Drawings based upon, or copied from, 2008 Survey by Ed Dennison Archaeological Services Ltd and proposed restoration by Ingleby and Hobson 2005

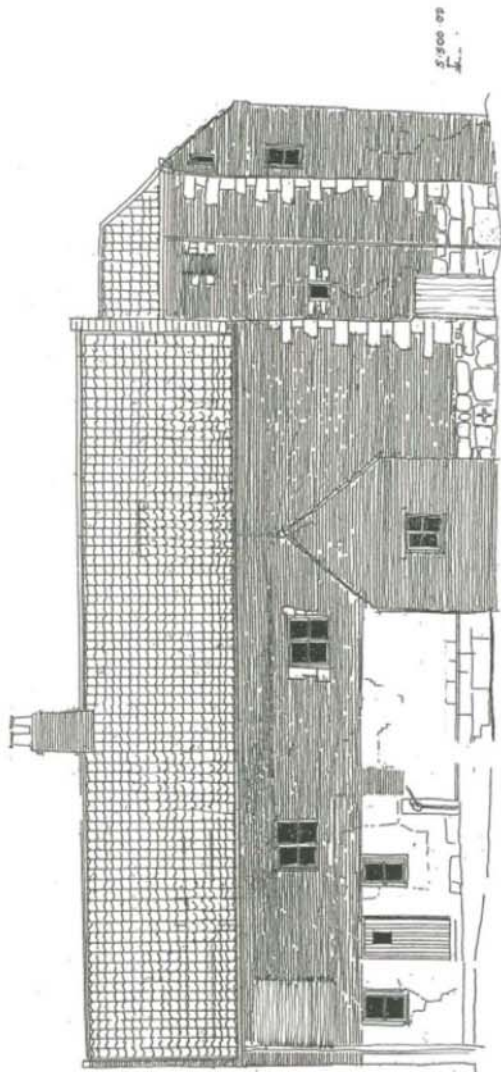
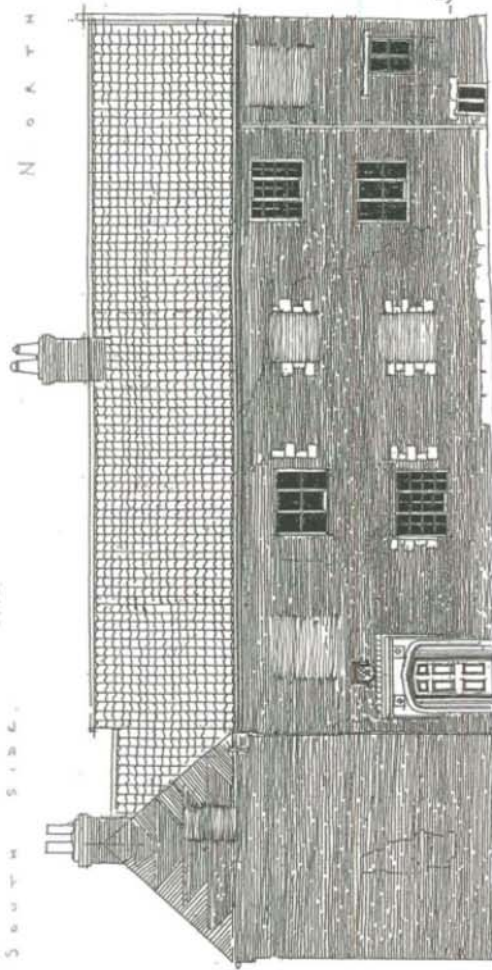
N O R T H E L E V A T I O N

S O U T H E L E V A T I O N

Drawings based upon, or copied from, 2006 Survey by EG Dennison Archaeological Services Ltd and proposed restoration by Ingleby and Hibson 2006

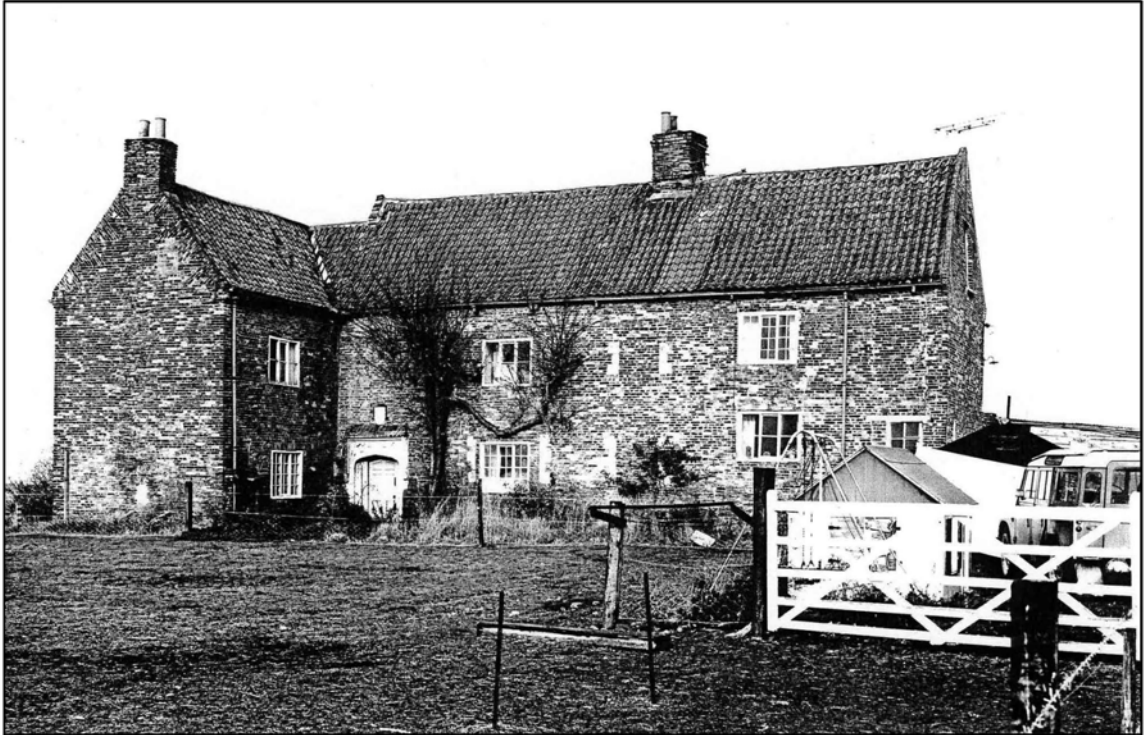
Haltemprice Priory farmhouse, looking North, November 1975 (© Crown copyright NMR BBBB77/7964)

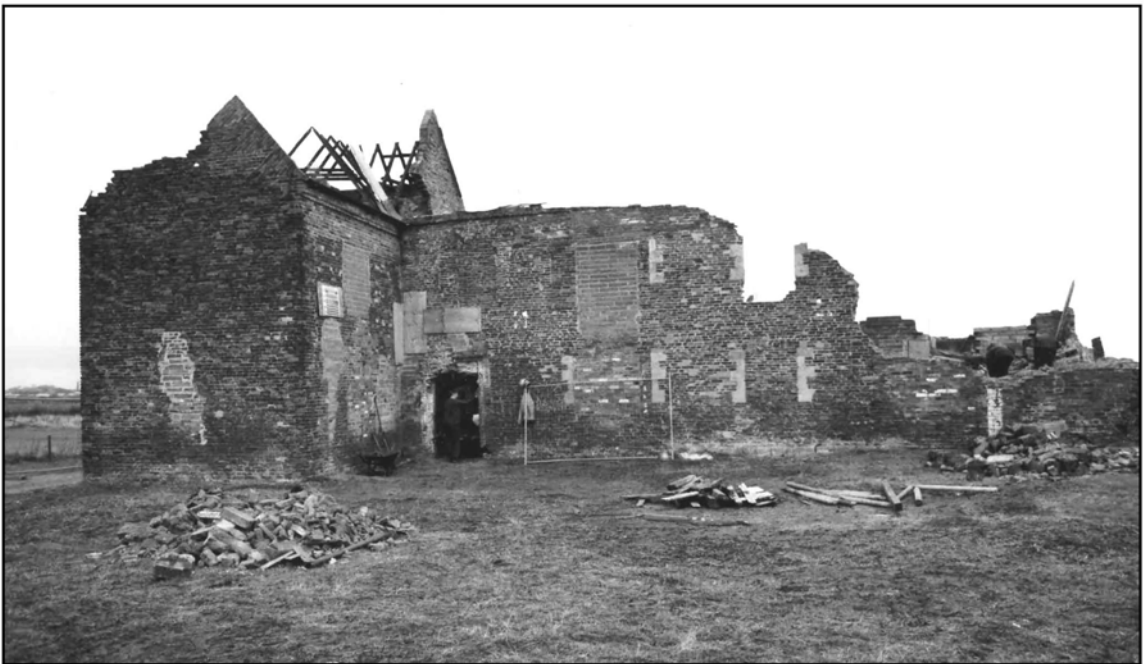
Plate 1: Haltemprice Priory farmhouse, looking north, December 2003 (photo 7/37)

Haltemprice Priory farmhouse, looking North, December 2003 (photo 7/37)

The site is made up of several different elements. The principal above-ground features are represented by the now ruined Haltemprice Priory farmhouse (see plate 1), which sits in the centre of a complex of poorly defined earthworks and other features; the earthworks are best depicted on the 1855 1<sup>st</sup> edition Ordnance Survey 6" map (sheet 225). The extent of the original Scheduled Monument covered the area to the north of the farmhouse, but this area was extended to cover land to the east and south, including the farmhouse, in February 2000 (see figure 2).

A wide range of brick types are used throughout the farmhouse, and the various phases of repairs and rebuilding often have mixed bricks of differing dates and sizes (see plate 1). A detailed report on the sizes and other characteristics of the brickwork of the farmhouse was undertaken as part of the current survey (Tibbles 2004) and this is reproduced in full as Appendix 3; a more detailed analysis of the local, regional and architectural significance of the brickwork is given in Chapter 7 below.

At the time of the survey (December 2003), the vast majority of the building was open to the elements, the roof timbers having either fallen or been burnt by fires lit by vandals (see plate 1). The exceptions were the common rafter roof over the stair-tower and the modern timbers over the south-west wing, both of which may date from the 1994 renovation works carried out by West Ella Holdings Ltd. However, by examining old photographs and the fallen timbers themselves, an impression can be gained of the form of the roof structures over the various parts of the farmhouse. It should be noted that, with the exception of the very large timbers, such as tie-beams, the position in which any fallen timbers were found in the building cannot be taken as indicative of their original position. There was much evidence for post-fall disturbance of the timbers, for example, pieces of the dark green painted doorframe of the main doorway in the south wall of the main range were found in three different locations. It was also noted in 1908 that the house had a "concrete roof or ceiling underlying the tiles and rafters" (Sheppard 1908, 22); this was removed during the 1994 works (Gelder and Kitchen 1992-93). 4.23 To date, no photographs or sections of the internal roof structure of the southwest wing or the stair-tower have come to light and the only known description of the former was made by Hall who stated that it was of "typical East Riding construction almost all in oak" (Hall 1976, 29). As noted above, at the time of the current survey, there were a number of narrow timbers running east-west across the south-west wing at eaves level, probably dating from the work carried out in 1994. During clearance of the interior, a single large timber was recovered, 4.40m long and 0.23m square. The length of this timber suggests that it once formed the tie-beam of a roof truss of the south-west range, and there were several indications that it was re-used. One end had either rotted away or been cut off, but at the opposite end, the form of the tenoned joint suggested that it may one have been connected to a post. Similarly, in the presumed soffit of the timber, there were two pegged mortices probably for braces, and also mortices in both sides of the beam, probably to support axial floor beams for floor joists. It therefore appears to have come from a timberframed structure and to have been re-used in the south-west wing.

Elevation 1 forms the external side of the south wall of the main east-west range (1/1) (see plate 1). Described from west to east, the principal feature is a four-centred arched doorway of moulded rubbed brickwork at the western end (3/22). The outer roll of the moulded jambs continues over the doorway arch and is surmounted by a sloping brick hood. As has been noted above, the brickwork of the doorway and that to its immediate east and west is clearly earlier than that forming the majority of the elevation; the earlier brickwork to the west incorporates two insets, the lower of which may be chamfered brick, and rises to a height of 2.20m above the existing ground level.

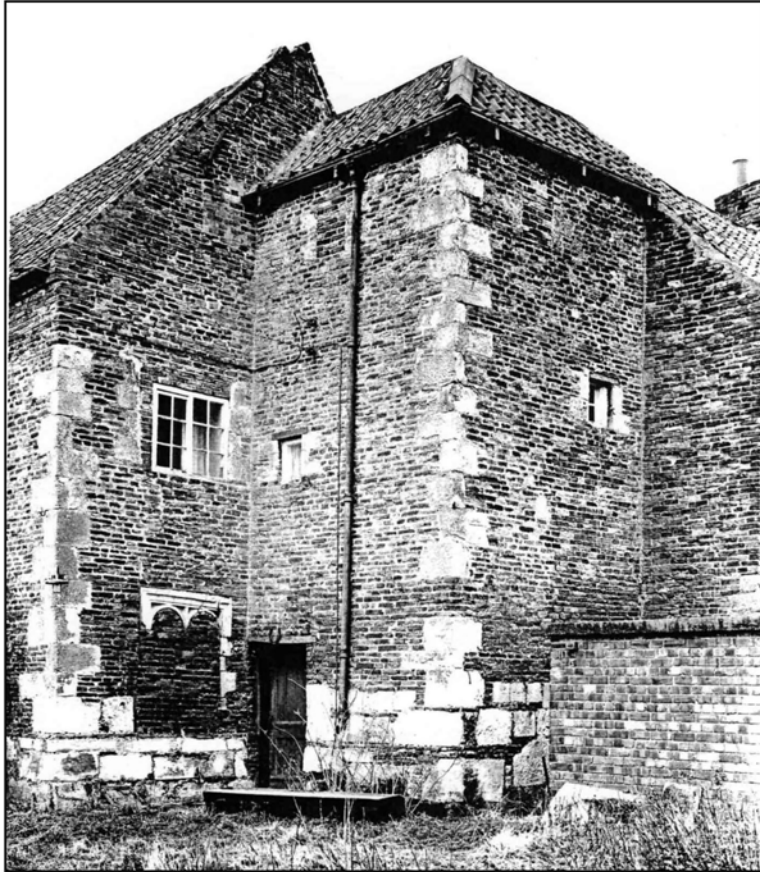
Stair-tower, looking South-East, November 1975 (© Crown Copyright NMR BB77/7974)

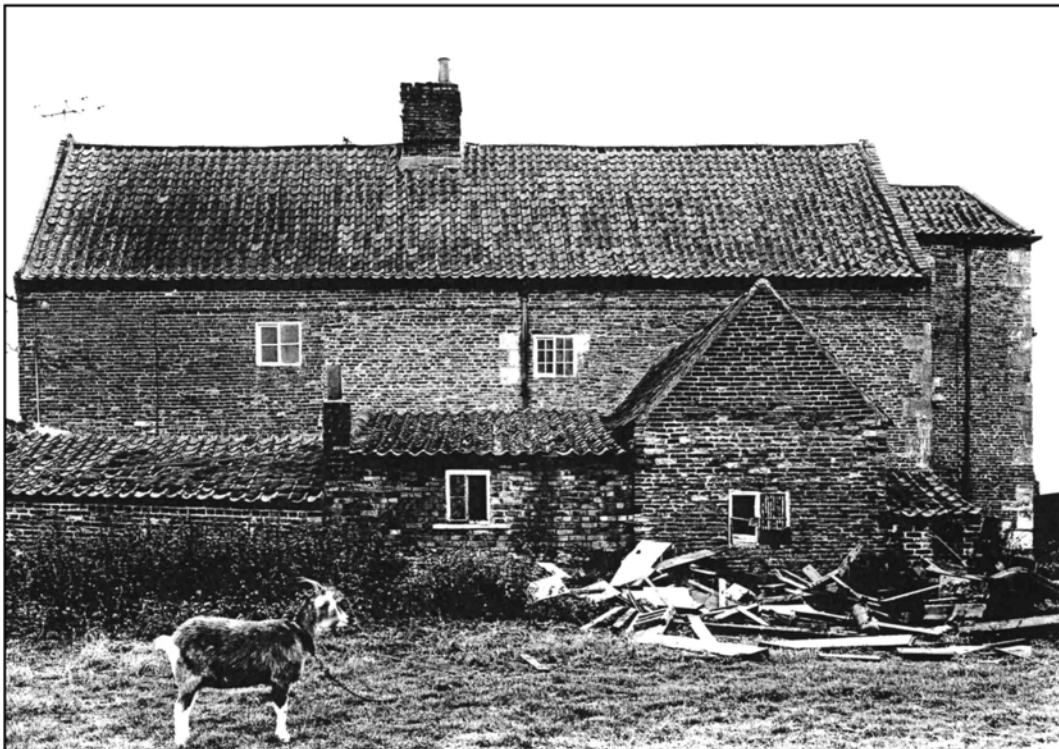
North side of farmhouse, looking South, November 1975 (© Crown Copyright NMR BB77/7969)

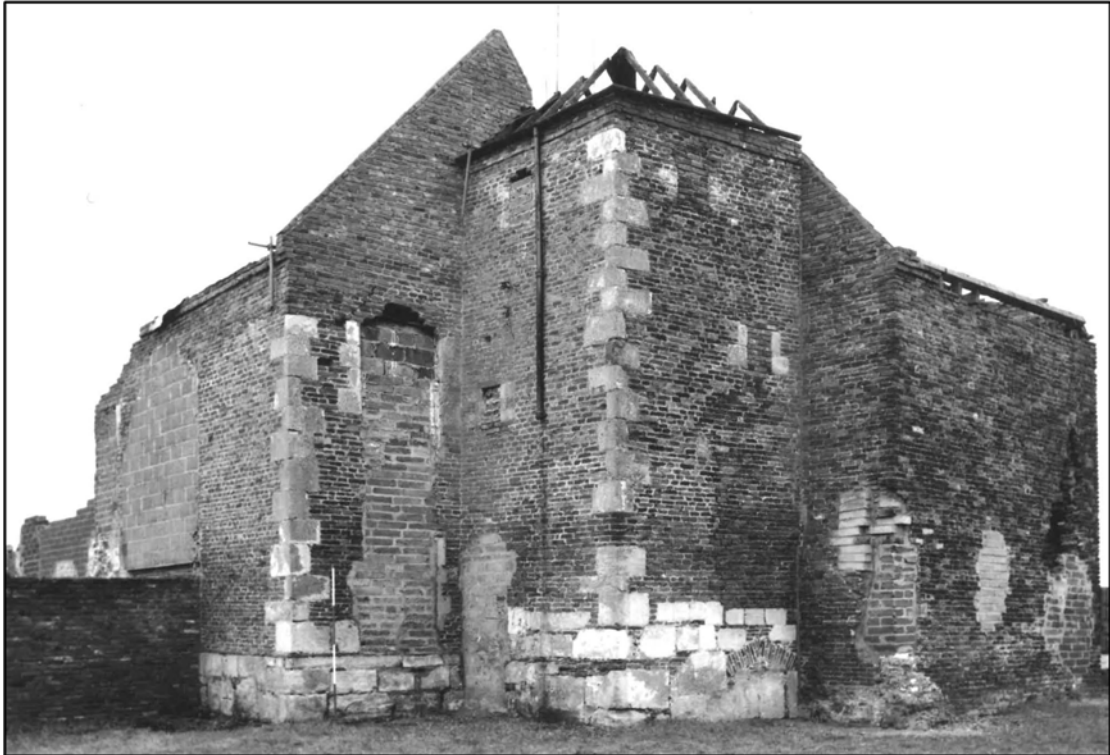
Plate 5: West side of farmhouse showing stair-tower, looking south-east, January 2004 (photo 1/8)

West side of farmhouse showing stair-tower, looking South-East, January 2004 (photo 1/8)

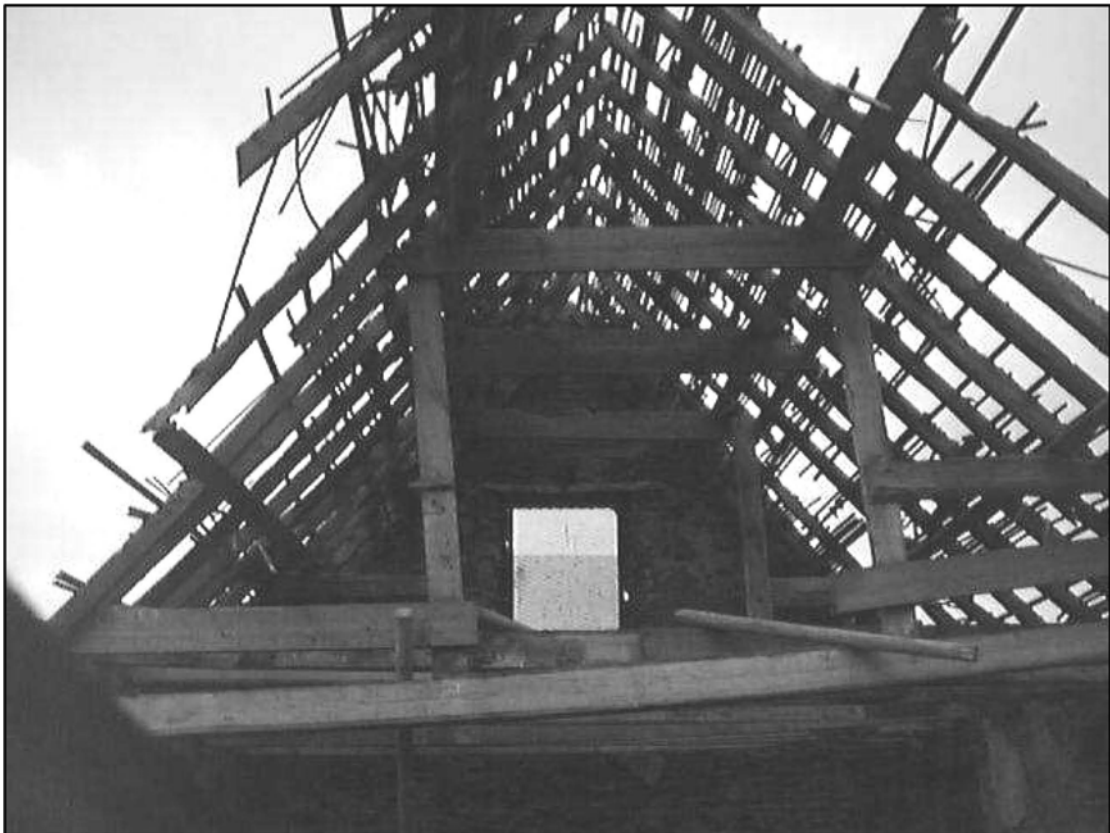
Roof structure over main range c.2004 (Hadgraft collection)

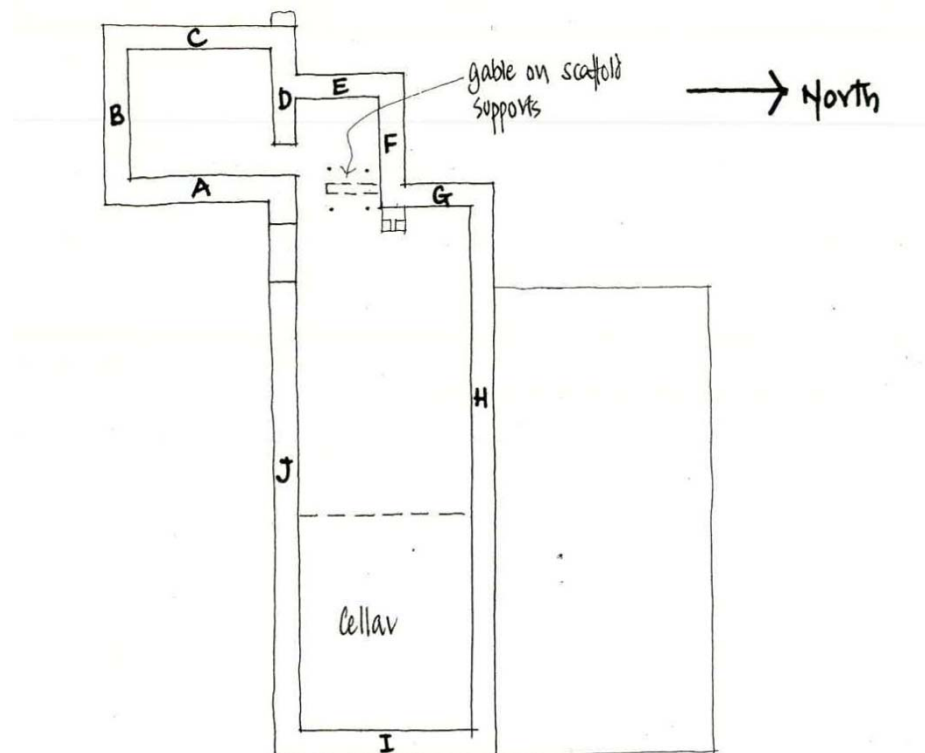
PLAN scale approx. 1:200

- 2.7 The walls are of clamp brick built in part off stone plinths, in lime mortar. They are around 700mm thick with timber lintels over openings. All ground floor window / door openings except for the present entrance in the south wall have been infilled, and the walls at the east end made up with blockwork to first floor level to prevent access.

- 2.8 Wall A: The inner, one brick, skin is completely missing up to first floor level and the brickwork above is precariously supported on three acrow props. Externally the wall has a noticeable outwards bulge at first floor level; this can be seen internally perhaps slightly less pronounced above the floor. The external face appears to have been re-pointed and the appearance of the brickwork above the first floor window suggests that it may have been re-built recently. At the junction with wall B there is what appears to be an old vertical crack. Part of the wall could have been rebuilt at some time but on the external face the crack has been filled and pointed and shows no evidence of opening up subsequently. In the corner with wall J there is a gap that has been filled with mortar in the past that has subsequently cracked. There is no evidence of significant structural movement so it is possible that the cracking is the result of thermal movement of wall J which faces south.

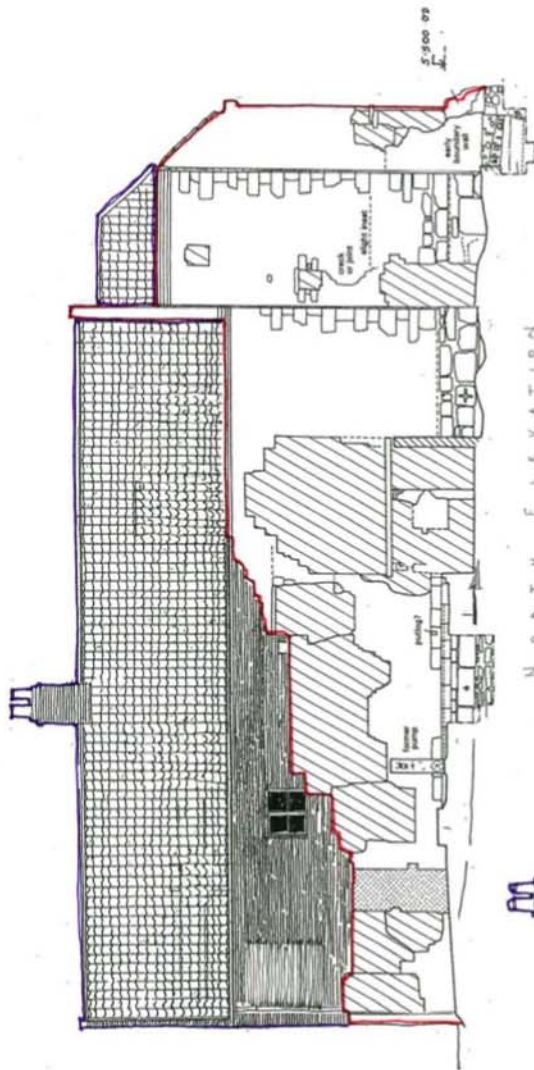
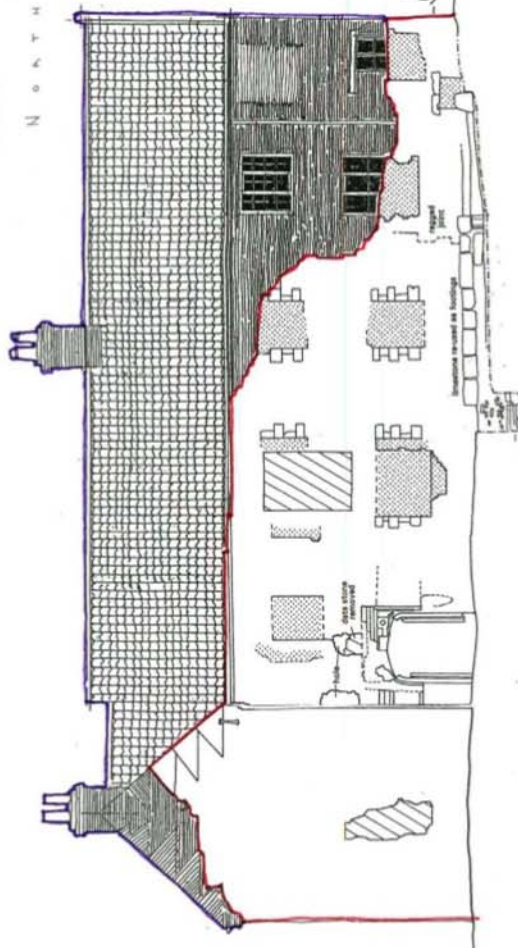
NORTH ELEVATION

- AREAS OF BUILDING REMAINS STANDING AS EXISTING
- MISSING SECTIONS SUPERIMPOSED (WITH SHADING IMP. DETAIL)

SOUTH ELEVATION

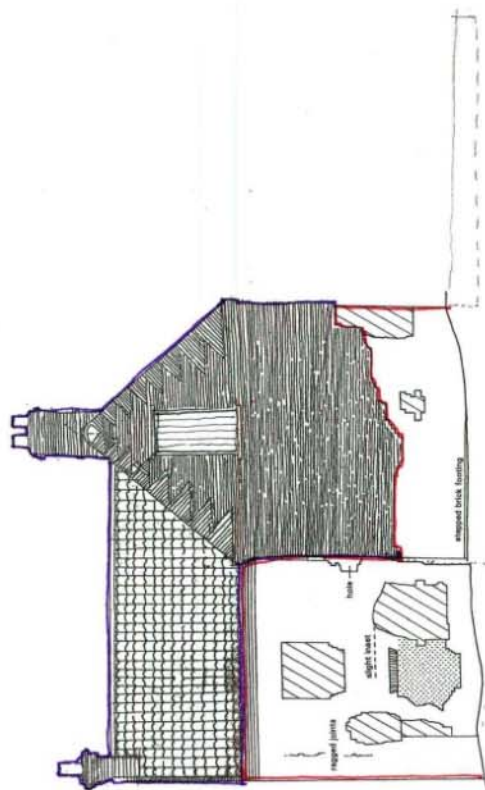
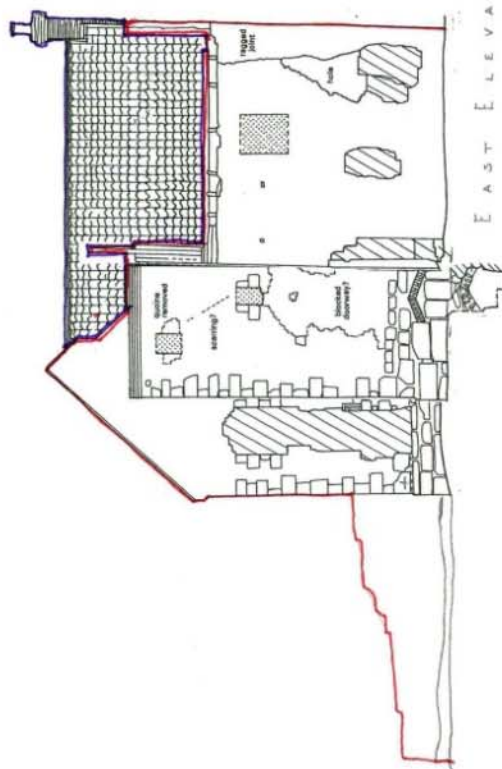
**HALTEMPRICE PRIORY FARMHOUSE**  
**WILLERBY, HULL**  
 PETER GAZE PACE, A.A. INC. 222, FLEDA,  
 THE OLD FACTORY, ROYAL WARRICK, YORK, YO41 1ED  
 T: 01904 717171  
 E-mail: peter@peterpace.co.uk  
 Mr. & Mrs M. Blades  
**ELEVATIONS AS EXISTING.**  
**OCT. 2011 DWG. 11.**

WEST ELEVATION

- AREAS OF BUILDING REMAINS STANDING  
 - MISSING SECTIONS SUPERIMPOSED  
 (SHADES - IMPL DETAIL)

EAST ELEVATION.

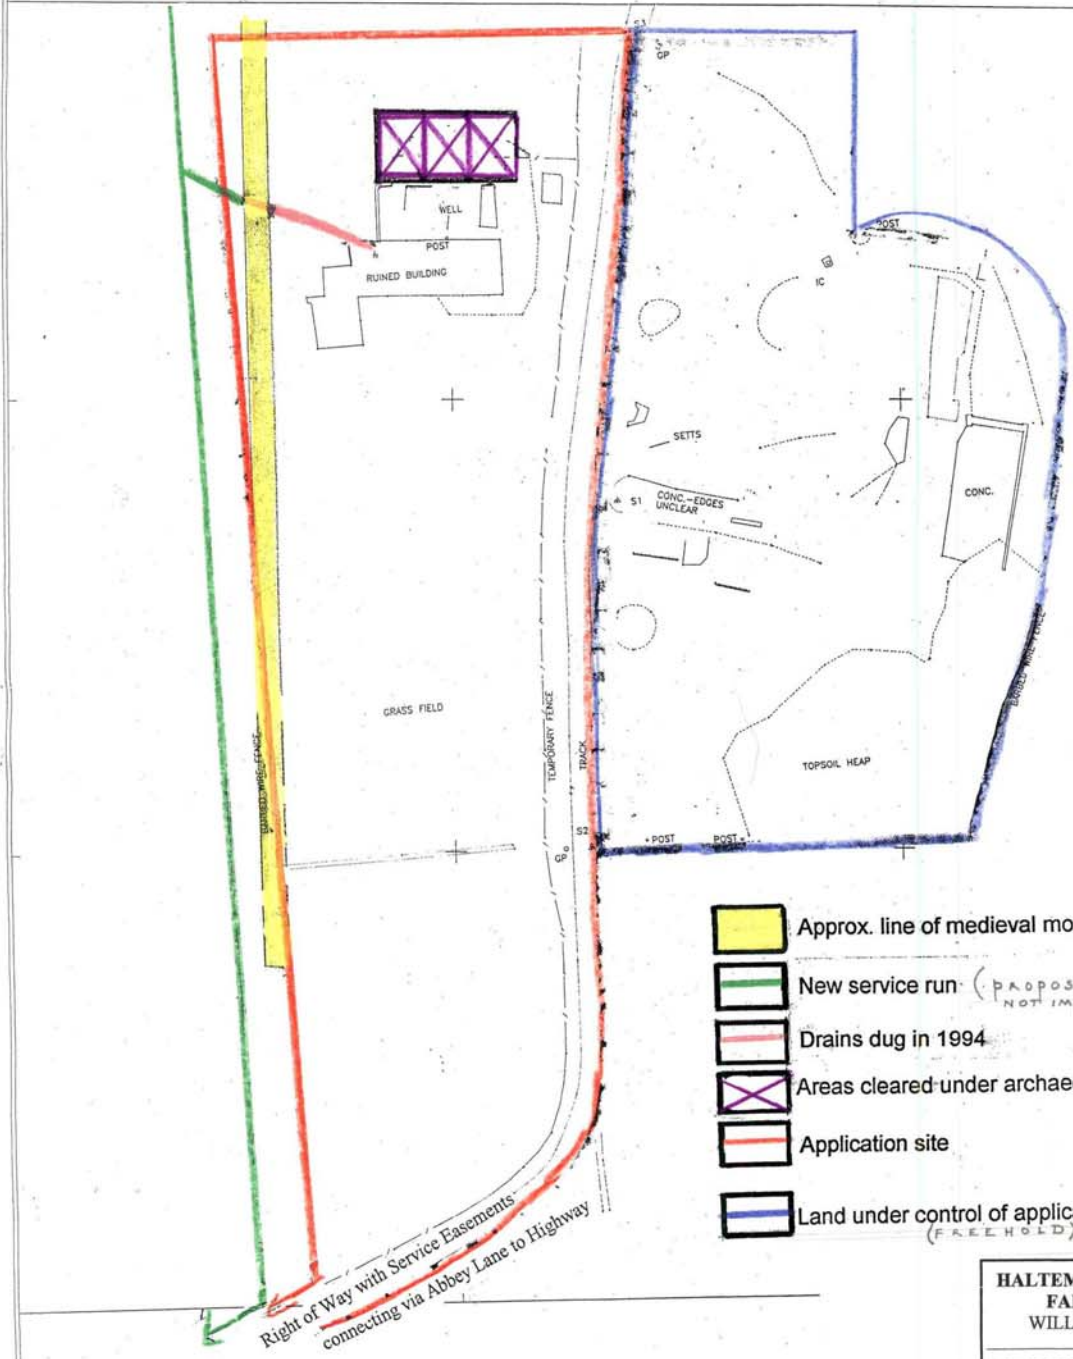
**SITE PLAN SERVICES / ARCHAEOLOGY**  
 OCT. 2011 DWG. 4

- Approx. line of medieval moat
- New service run (PROPOSED 2005 NOT IMPLEMENTED)
- Drains dug in 1994
- Areas cleared under archaeological watch
- Application site
- Land under control of applicants (FREEHOLD)

**SITE PLAN** SCALE 1:500  
 Showing Boundaries, Services and Relationship with Relevant Archaeological Work

The important archaeological remains below ground will not be affected as main services are already in place. The footprint/foundations of the 1988 farmhouse will not be exceeded. Paths and hard standings to be laid on top of the surfaces.

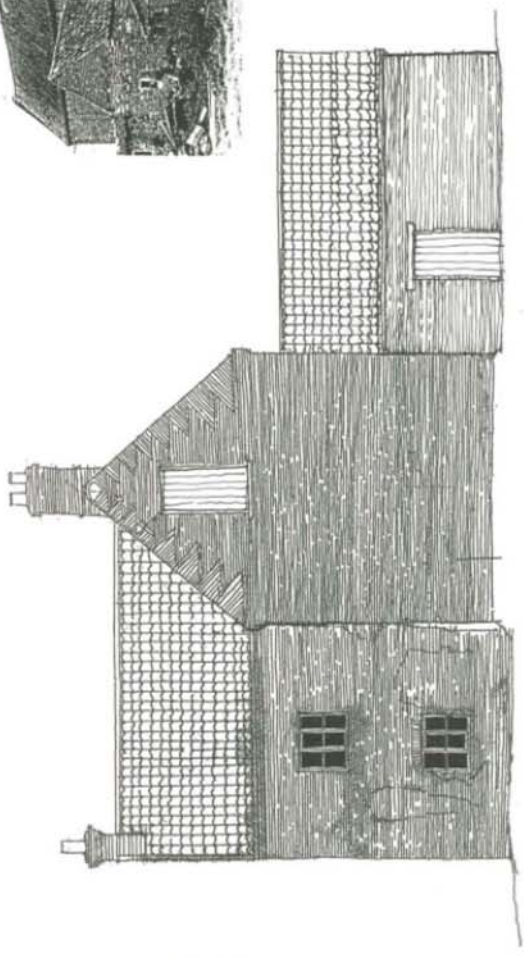
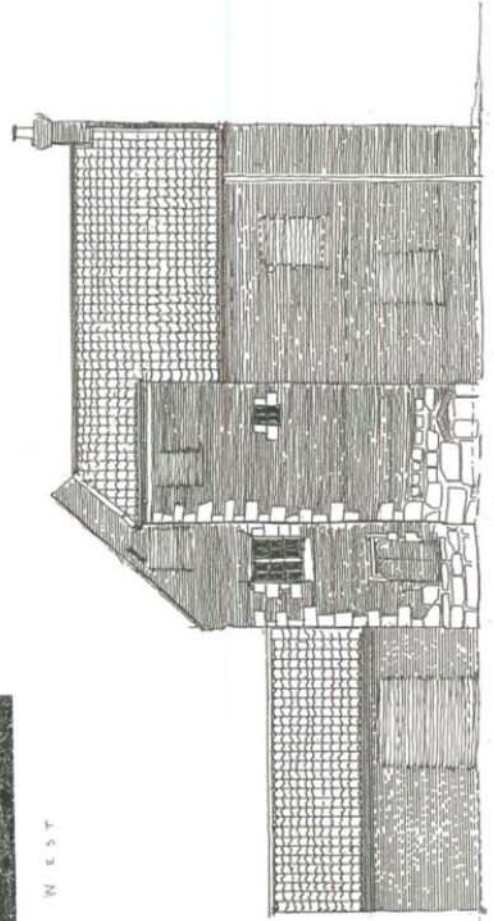
EAST ELEVATION

WEST ELEVATION

Drawings based upon, or copied from, 2006 Survey by Ed Dennison Archaeological Services Ltd and proposed restoration by Ingleby and Hobson 2005

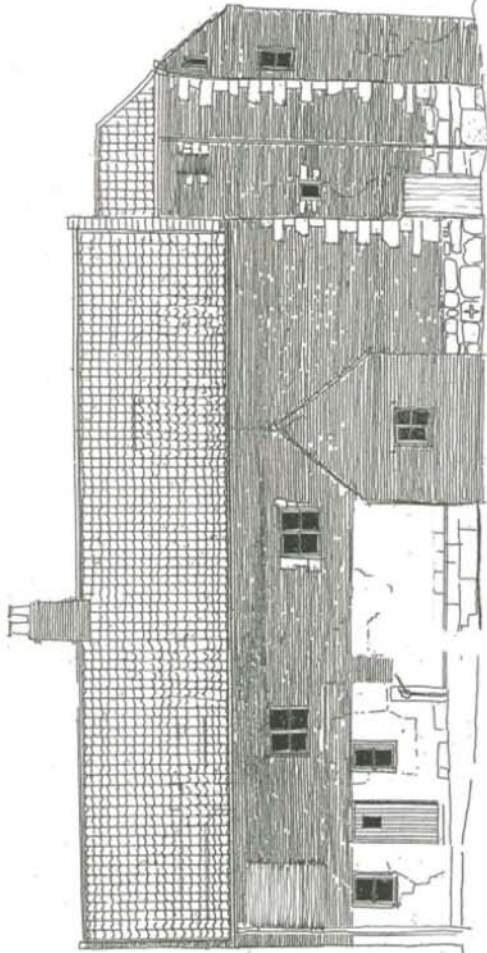
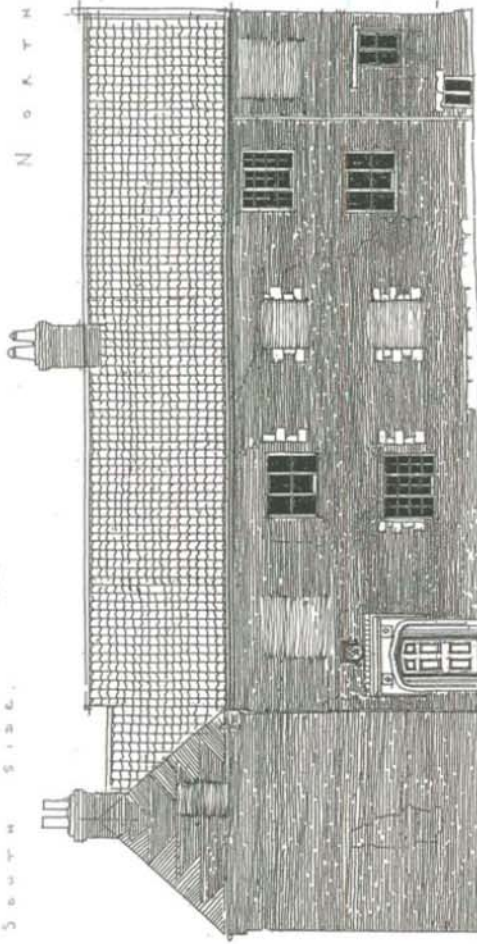
NORTH ELEVATION

SOUTH ELEVATION

Drawings based upon, or copied from, 2008 Survey by Ed Demison, Archaeological Services Ltd and proposed restoration by Ingleby and Hobson 2005

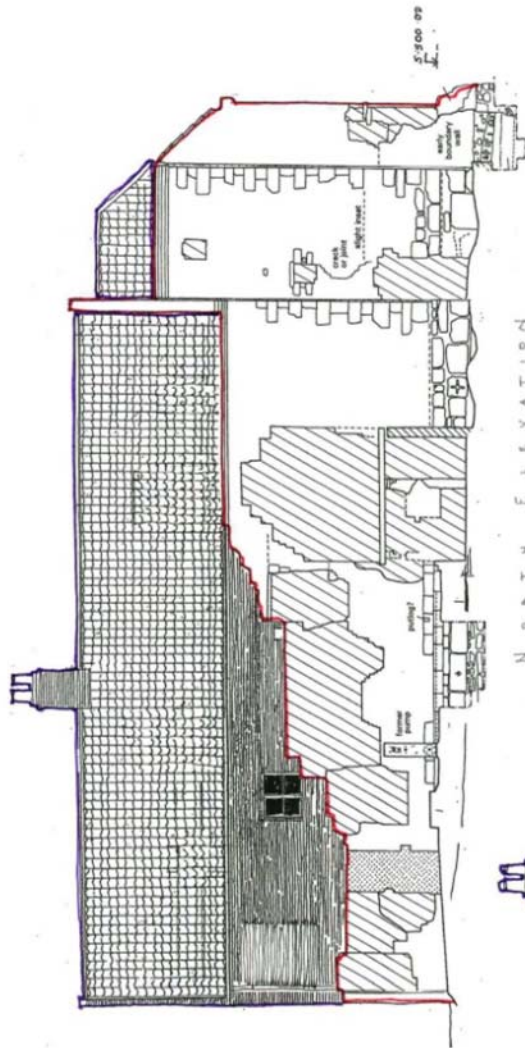
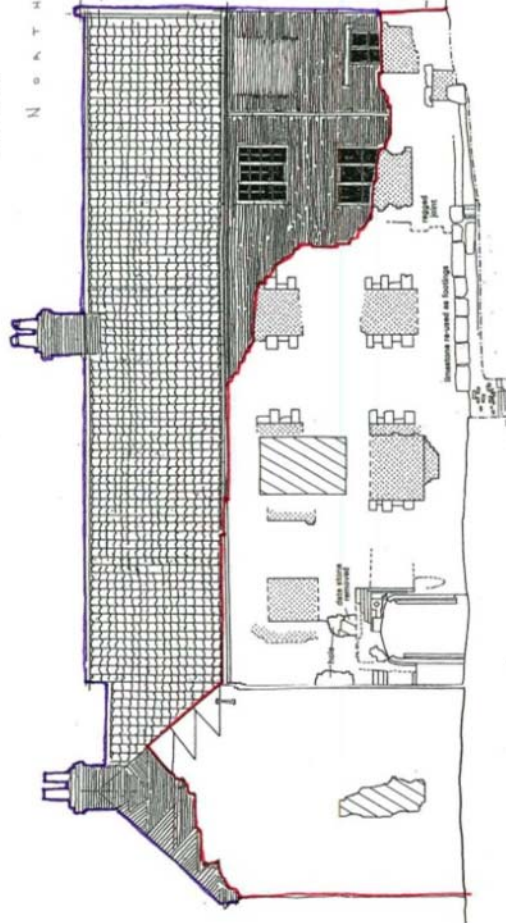
N O R T H E L E V A T I O N

S O U T H E L E V A T I O N

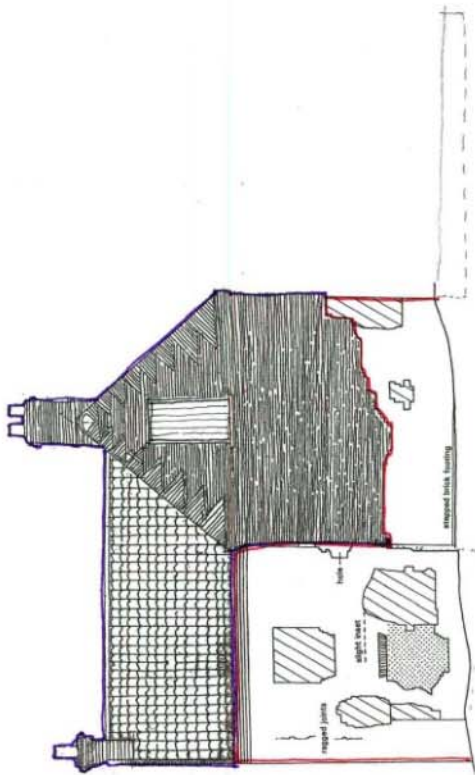
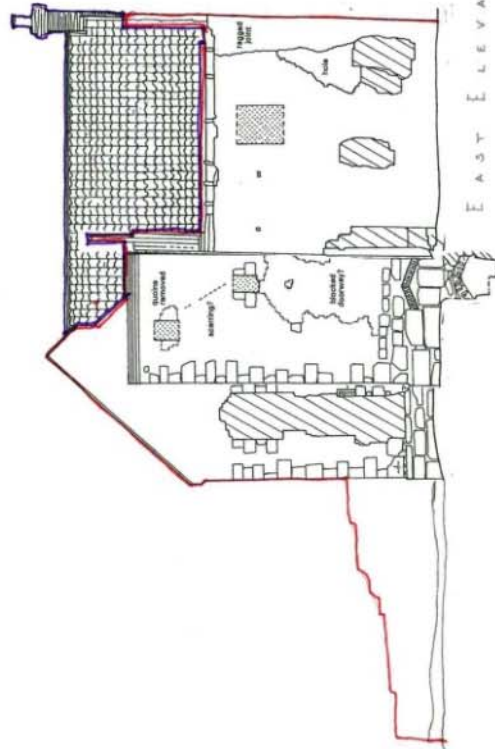
WEST ELEVATION

EAST ELEVATION

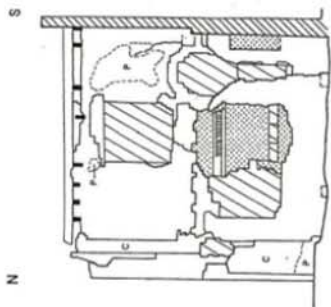
Elevation 12: south-west wing, east internal

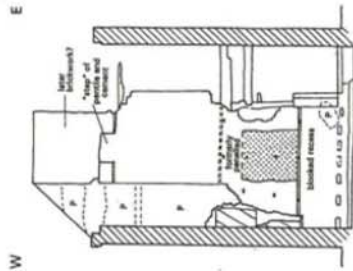
Elevation 15: south-west wing, north internal

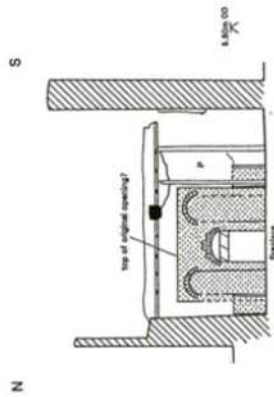
Elevation 18: main range, internal

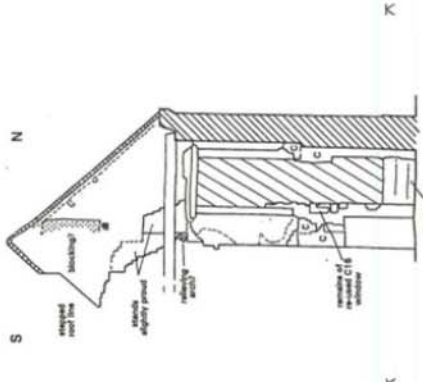
Elevation 16: main range, west internal

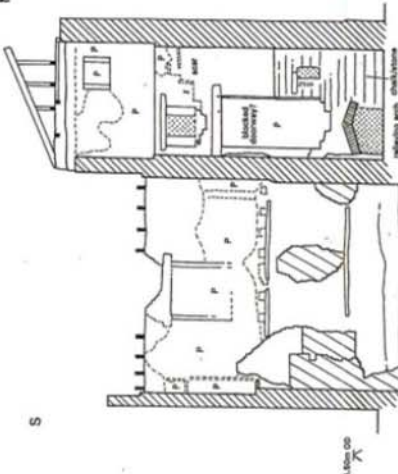
Elevation 14: south-west wing and stair-tower, west internal

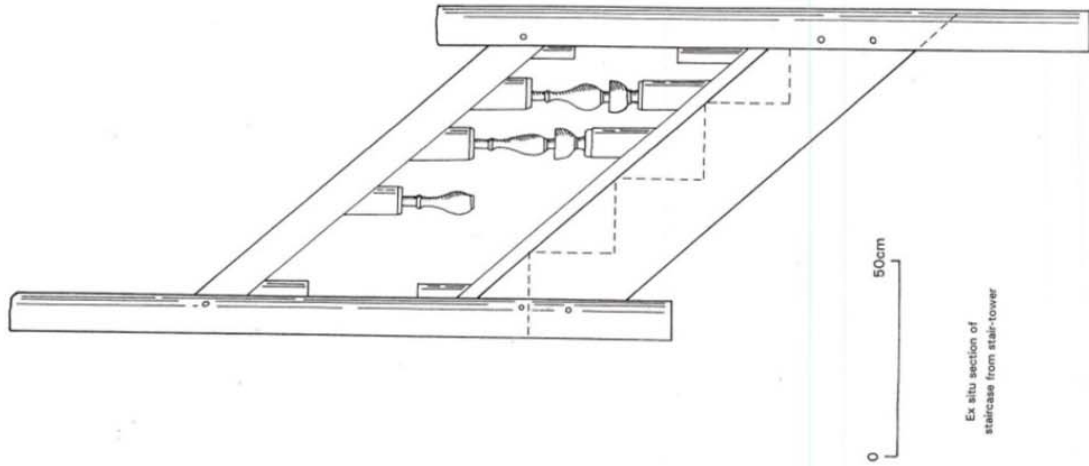
Ex situ section of staircase from stair-tower

Typical profile of moulded ceiling beam, main room in main range

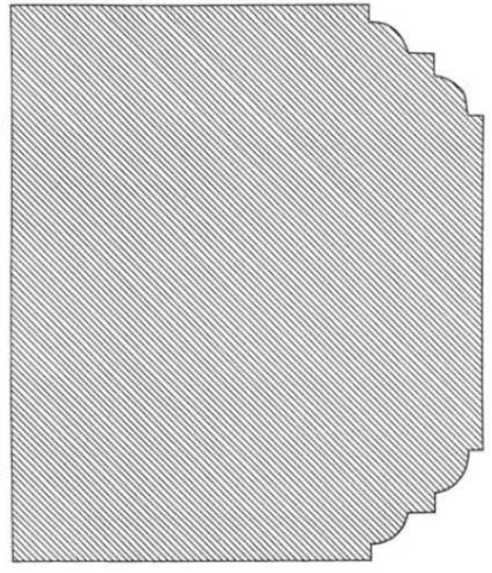
Profile of staircase handrail

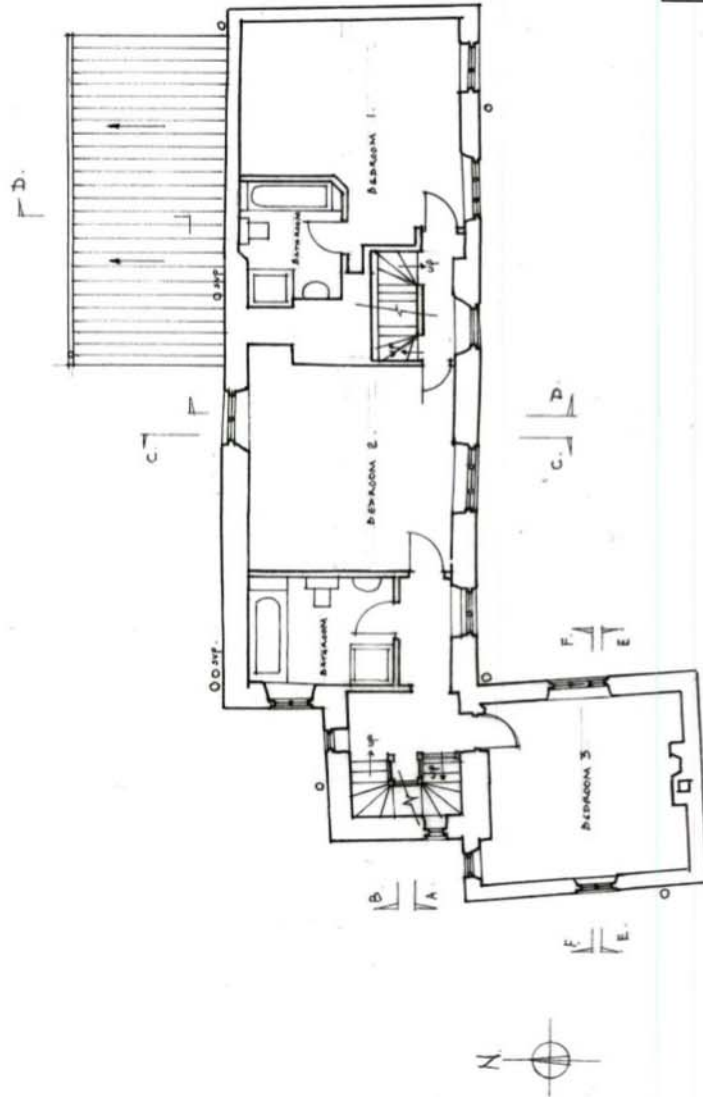
**FIRST FLOOR  
AS PROPOSED**

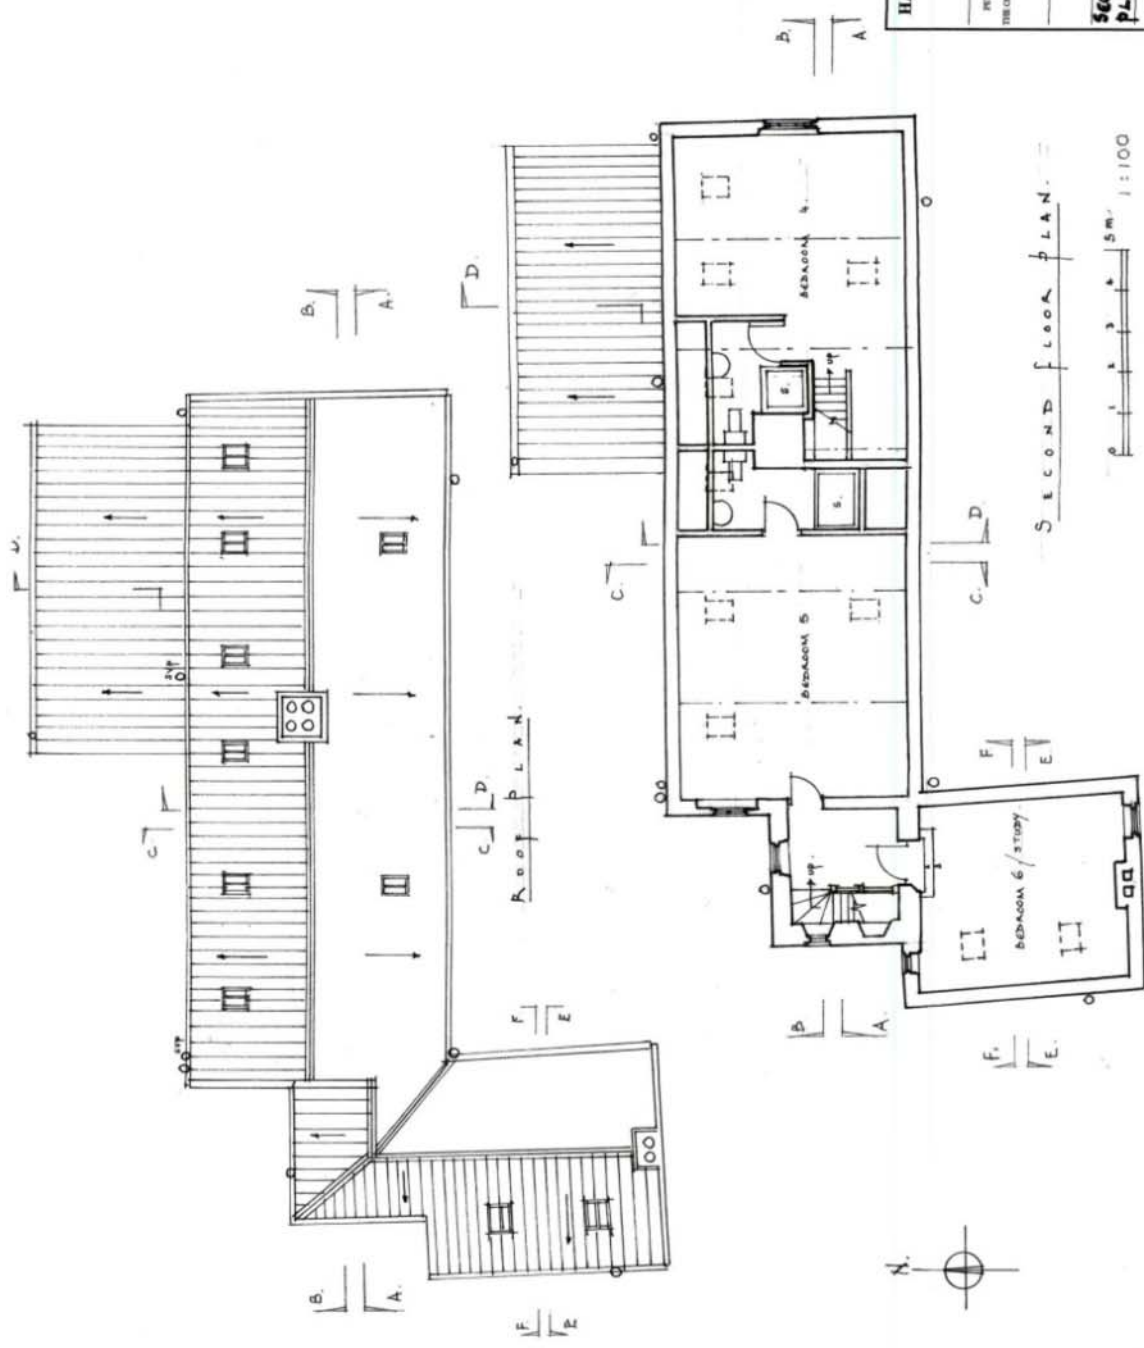
**HALTEMPRICE PRIORY**  
**FARMHOUSE**  
**WILLERBY, HULL**  
 PETER GAZE PACE, A.A. THE REGAL, 28 BRIDLE  
 THE OLD FACTORY, SEAFORD ROAD, YORK, YO1 1ED  
 Email: peter@peterpace.co.uk  
 Mr & Mrs M. Blades  
**SECOND FLOOR AND ROOF**  
**PLAN - As proposed**  
**OCT. 2011 DWG. 23.**

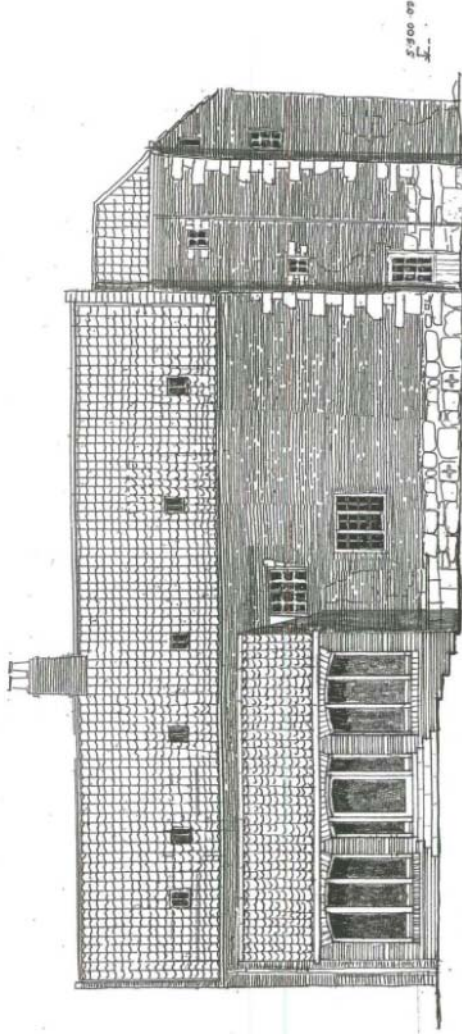
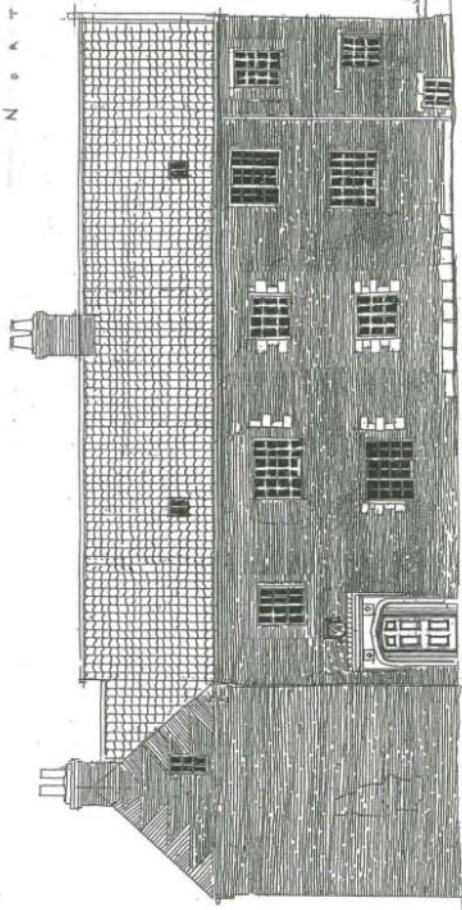
N O R T H E L E V A T I O N

S O U T H E L E V A T I O N

ROOF - HANDMADE CLAY TILES  
 SKYLIGHT - CORRUGATED METAL FRAME  
 RAHWATER GOODS - CAST IRON. GUTTERS  
 ON ROOF AND FALL BAGNETS  
 WALLS - BAUER HANDMADE / SHAVED  
 WINDOWS - GUNNING SASH TRADITIONAL DETAIL  
 DOORS - HANDMADE STAINED & PAINTED  
 REPAIRS TO STAIRING ALONG IN JUNE 2011

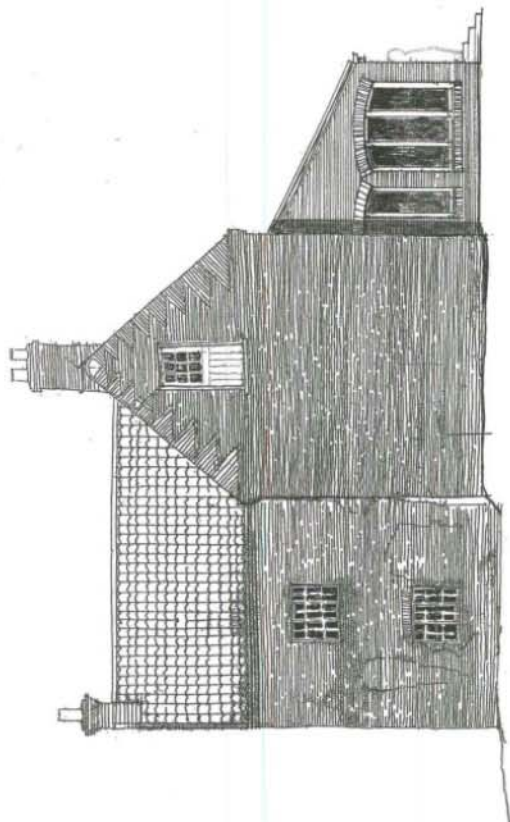
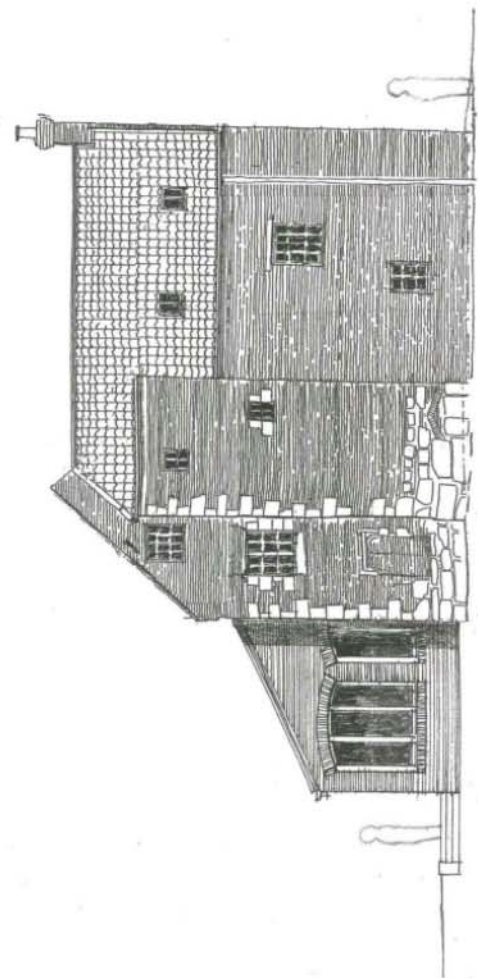
E A S T E L E V A T I O N

W E S T E L E V A T I O N

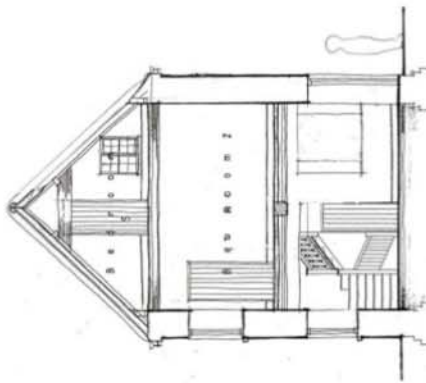
SECTION C - C

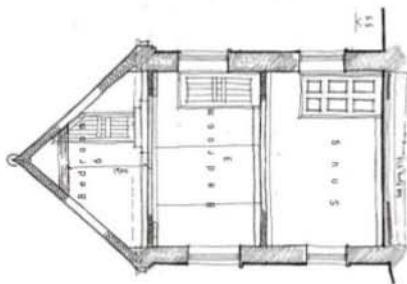
SECTION F - F
